Inspection Report

000 sample way, Peachtree City, Georgia 30269

Inspection Date July 26, 2017
Client Maria Clark
Inspector Bruce Wu

Pro Home Services

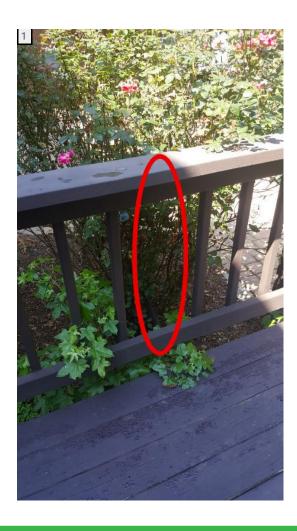
Balusters are damaged or missing

Impact Deficient balusters reduce the stability of the railing

Suggested Action Replace the missing component

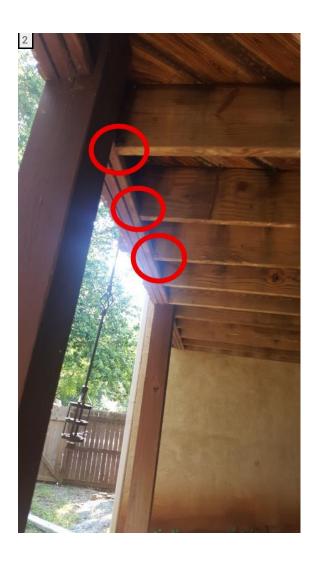
A proper flashing should be provided at the intersection of the exterior wall of the house and the deck ledger band to avoid leaks into the structure through the bolt holes as required by present day codes. This can be achieved by removing the decking next to the structure and then installing the flashing over the ledger band. The upper end should be caulked or slid under the siding if present.

The floor joists on the deck are toenailed to the ledger board which compromises the integrity of the deck. Joist hangers or an equivalent system are necessary to support the joists and prevent potential deck failure

Location Exterior: Ground View Suggested Action recommend install the flashing

Location Exterior: Ground View Suggested Action recommend install the joist hangers

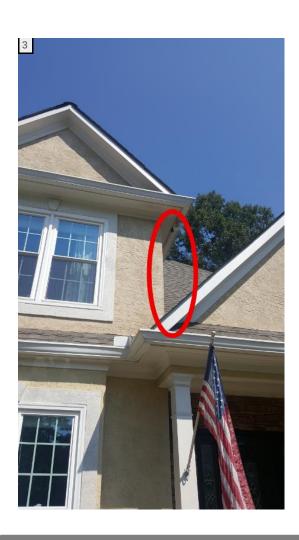
Bottom elbow is missing

Impact Without an elbow, water drainage is not optimally contained

Suggested Action Install a downspout elbow and install downspout extensions to discharge

rainwater 4 - 6 feet away from the building

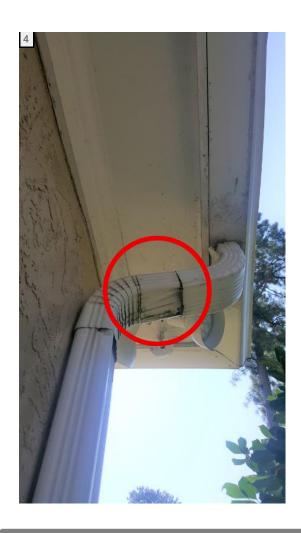
Damaged

Impact A damaged downspout weakens the structure of the downspout and alters

the water flow

Suggested Action Replace the damaged portion of the downspout

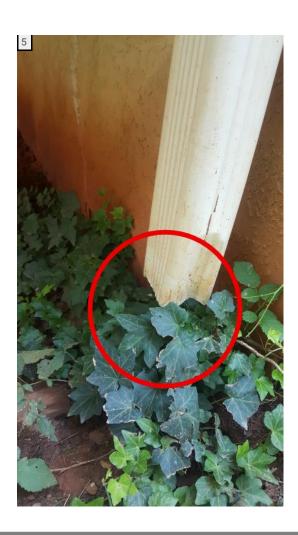
Extensions are missing

Impact Water flow is not contained and may drain near foundation increasing the

risk of flooding

Suggested Action Install downspout extensions reaching 5-6 feet from the building

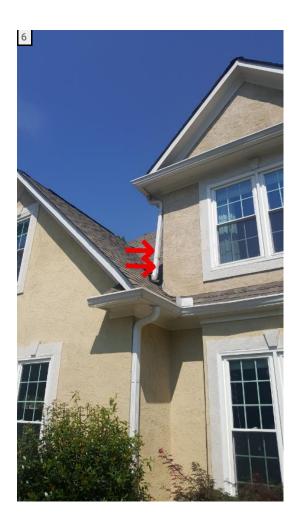
Fasteners are not held tight to the building

Impact Without proper fasteners, the downspout could further pull away

Suggested Action Resecure or replace the fasteners

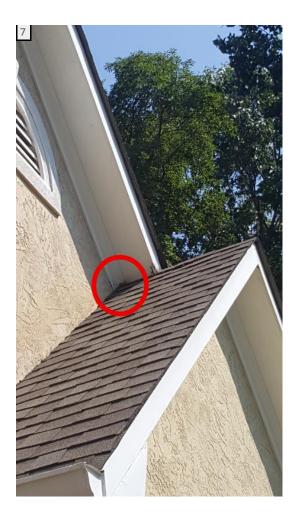
Fascia paint is chipped, faded or worn

Impact Untreated fascia is at risk of premature aging due to exposure to the

elements

Suggested Action Repaint

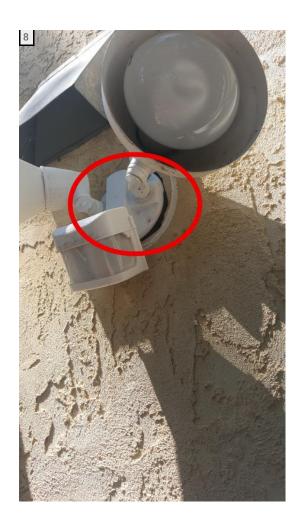
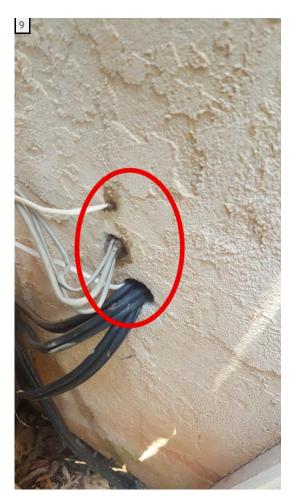
Caulk has aged leaving holes or gaps

Impact The gaps could allow for moisture and insect intrusion which may cause

cause damage to the wood over time

Suggested Action Repair the caulking

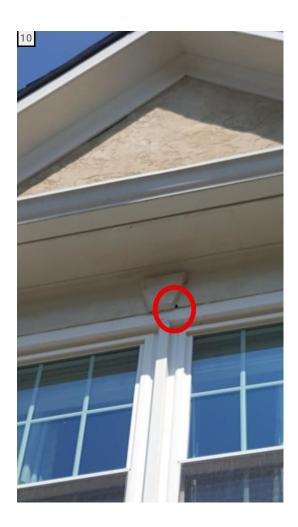
Stain, paint or sealer has peeled, faded or bleached out

Impact Unprotected wood is at risk of premature aging due to exposure to the

elements. If it becomes rotted, it reduces protection from insects, animals

and the elements intruding into the home

Suggested Action Restain or paint the trim

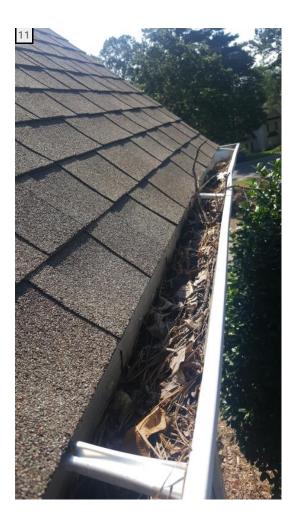
In need of cleaning

Impact The gutters may clog causing water to overflow and run down fascia board,

potentially wearing wood before its time

Suggested Action Clean the gutters

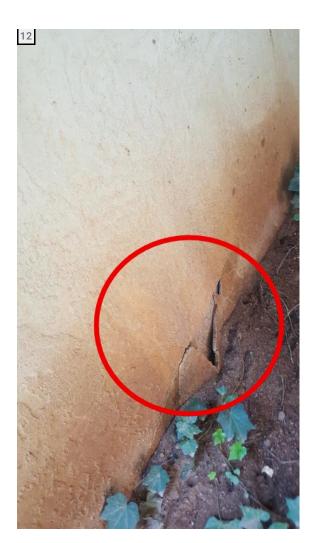
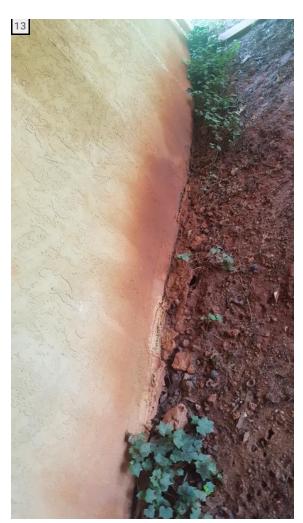
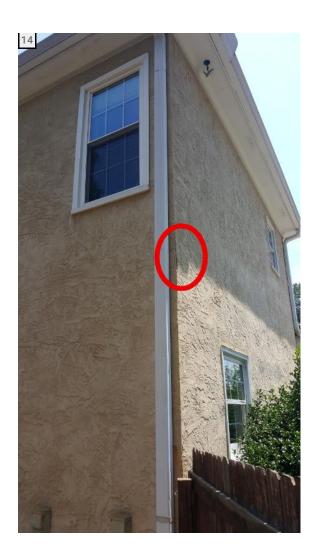
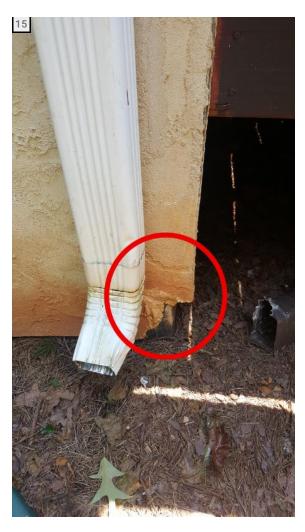
Stucco is cracked

Impact Cracked stucco may allow for moisture and insect intrusion Suggested Action Have a certified stucco contractor repair the affected areas

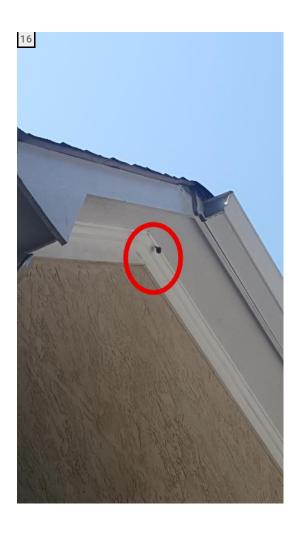
Bee comb found

Location Exterior: Ground View Suggested Action recommend remove.

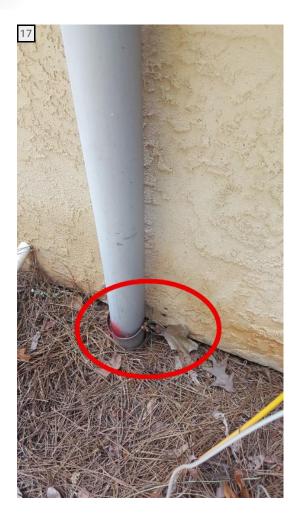
The service mast/conduit should be better secured to the exterior of the home.

Location Exterior: Ground View Suggested Action recommend repair

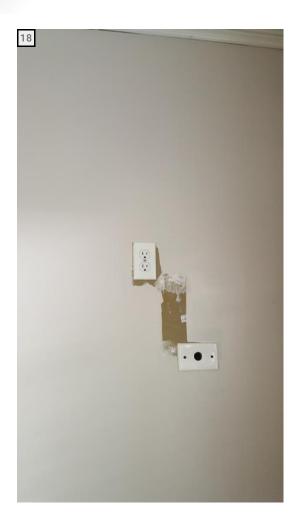
Appears to have no power

Location 1st Bedroom Master, Basement Room
Suggested Action Have repaired by a licensed electrical technician

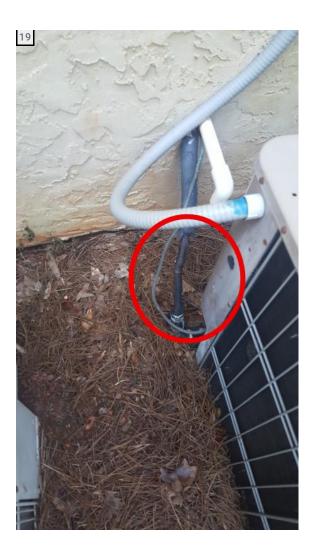
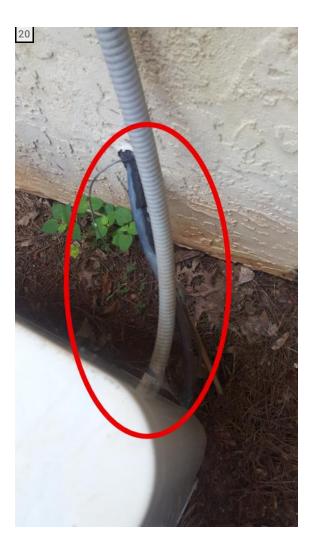
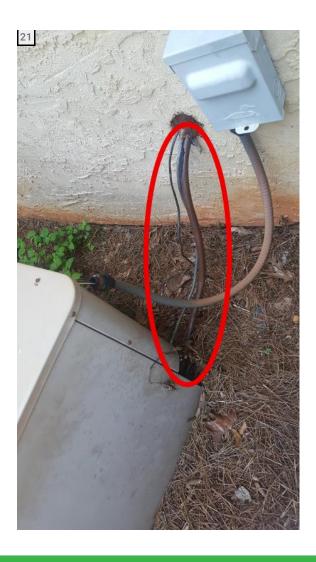
The unit for the basement is not working

The condensate line for the air conditioning system should be improved at the outdoor unit. At the exterior of the home the line should extend further away from the home to prevent ponding at the foundation and be placed inside conduit to prevent crushing.

Suggested Action Have serviced by an HVAC service professional

Location Exterior: Ground View Suggested Action recommend repair

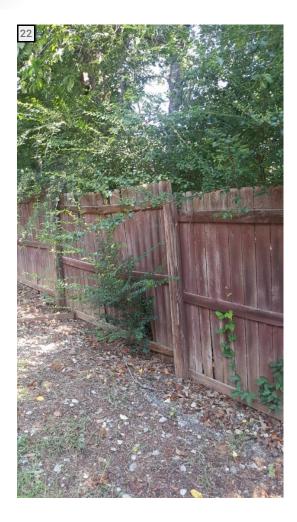
Damaged

Suggested Action Repair the damaged areas of the fence

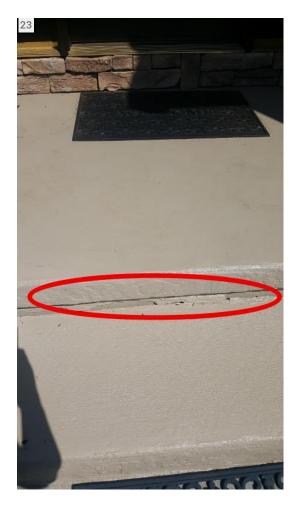
Gap between concrete walkway and building, stoop or other structure

Impact Gaps provide an environment for moisture intrusion with the possibility of

expansion during the winter months

Suggested Action Fill all gaps with a pliable weather-resistant concrete sealer

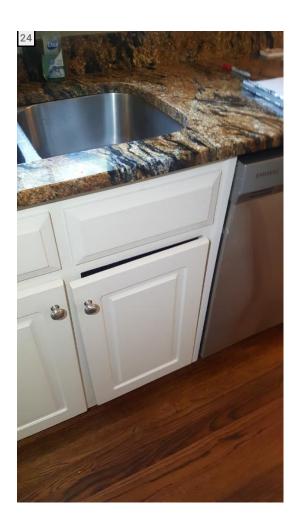
Door frame is loose

Impact If not repaired it will become looser and the screws may become stripped

Suggested Action Secure door frame to cabinet

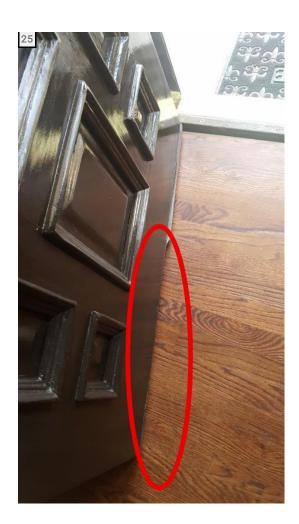
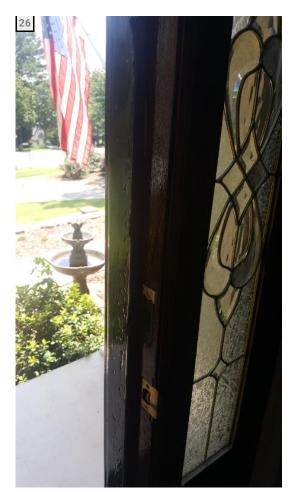
poor weather sealed

Impact Without proper protection, the door is not protected from the elements

Suggested Action Protect with weather-resistant seal, stain or paint

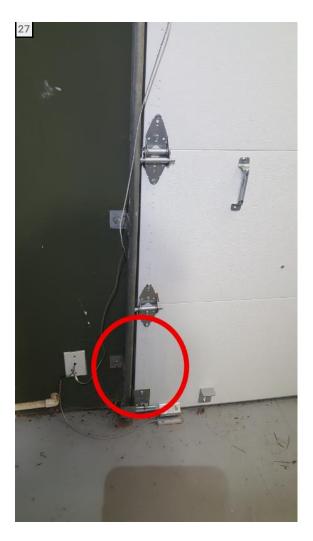
Basement Garage door is not working, no power link to the opener. The floor sensors for the garage door opener are missing. There is a serious risk of injury, particularly to children, under this condition.

Suggested Action Recommend a qualified garage door professional check and install the sensors as needed.

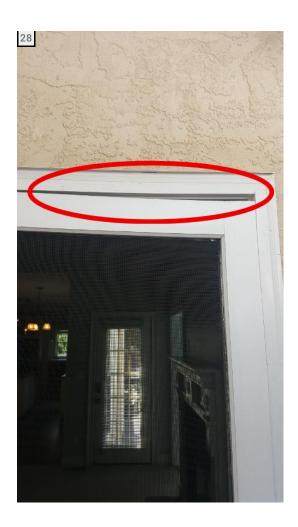
unprofessional install.

Suggested Action Recommend repair or replace by a licensed professional.
